# SPWLA INDIA CHAPTER

**Quarterly Bulletin**  
**Volume 4 Issue 1**  
**April-June 2023**

### Geo-mechanical Analysis: Understanding Casing Deformation in Wells of Limbodra Field

## Innovative approach using temperature logging helps restore casing integrity and revival of sick well. A Success Story from Lanwa heavy oil field of ONGC, Mehsana

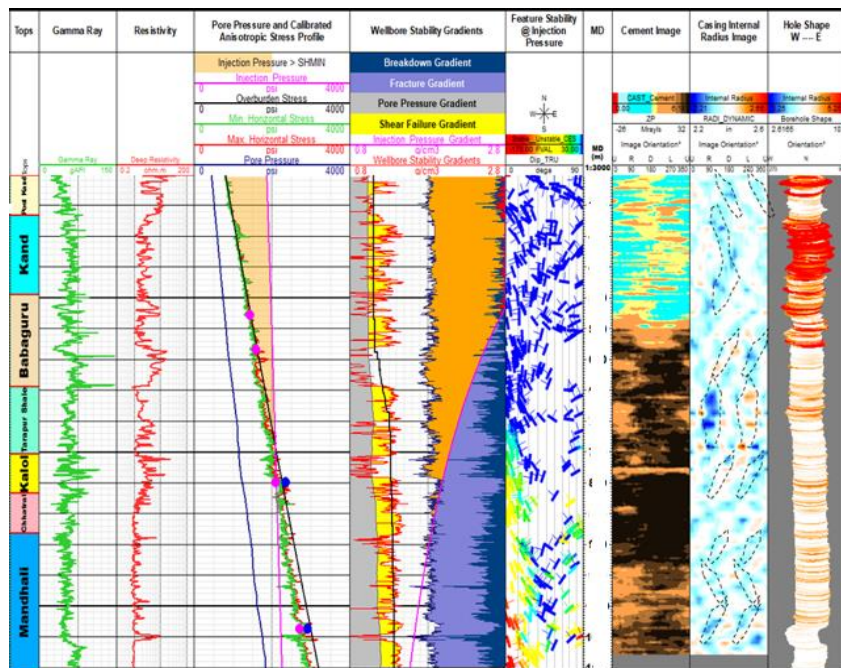
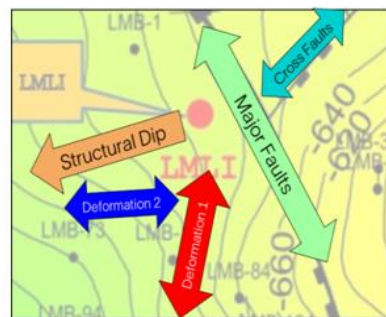
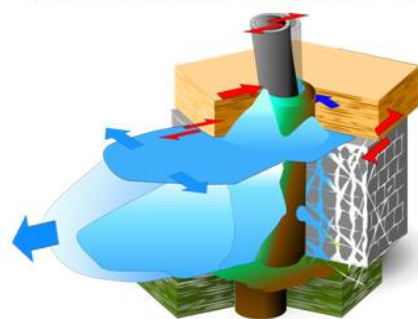
Figure 1: Log motif

In order to understand the stress regime anisotropy and identify structural features responsible for the anisotropy, the Geo Mechanical Analysis tool (Sonic Scanner) acoustic logs were recorded in one of the recently drilled wells of the field. Anisotropic geo-mechanical study of the logs showed that a strike slip stress regime is prevalent above 575m depth and therefore, the formations, casing and cement in the shallower intervals of the well are exposed to higher than normal lateral stresses. Based on modelling, it is seen that many natural features in this interval became unstable when exposed to an increase in pore pressure. The structural features have a strong tendency to open up and move due to shear slip-slide failure mechanism upon exposure to an increase in pore pressure. The same unstable structural features appear to be responsible for hole tortuosity, poor cementation and casing deformation in the well. It also indicates that, residual stresses exist in the casing prior to production or injection due to exposure to drilling fluids and cement slurry ECD surges. Stress state and slippage tendency was used to identify re-activation surfaces where casing deformation would initiate. The high-pressure injection water appears to communicate with the shallower formations through imperfections in the cement sheath as evident from the cement bond images. The injection water is anticipated to move as a fluid front through permeable sands and leak off through the unstable structural features. The high-pressure injection water is responsible for aggravating shear slip-slide failure of the unstable structural features. Consequent formation movement will transfer lateral stresses on to the casing's external surface in a non-uniform / anisotropic manner. In the absence of cement, the lateral stresses compress the casing along the SHmax in the horizon above 575m. The combined effect of the non-uniform compressive stresses, residual stresses and the pressure differential between the internal and external surfaces appears to be compressing the casing beyond its collapse ratings. Onset of collapse of 9-5/8" casing is anticipated before the 5.5" casing in such situations.
